## Performance Evaluation of a Trunk-A Road in North Central Nigeria

### ABSTRACT

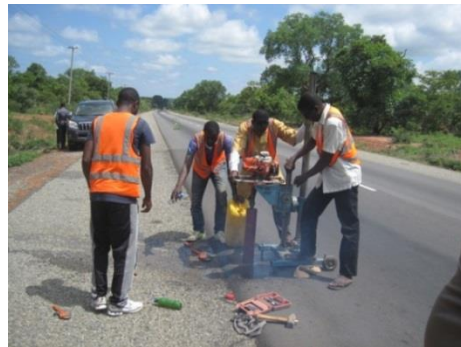
Fig. 2. Coring through the pavement structure..

- Coring through the pavement structure (Fig. 2);
- Collection of core samples of asphalt (Fig. 3);
- Evaluation of thicknesses of asphalt, base and sub-base courses;
- Dynamic Cone Penetration (DCP) test (Fig. 4) to infer CBR values of Base, Sub-base and Sub-grade.

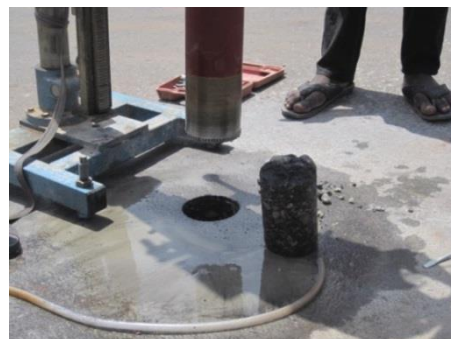
Fig. 3. Collection of core samples of asphalt.

Laboratory tests, carried out on the cored asphaltic samples included Marshall Stability test, bulk density test, bitumen content test, flow test, void ratio test, determination of percentage voids filled with bitumen and aggregate grading test. Marshall Stability and flow of asphalt mixtures tests were conducted according to ASTM D6927-15 [37], while bitumen content extraction test was carried out using Centrifuge Extraction Procedure, as highlighted by ASTM D2172/D2172M-11 [37].

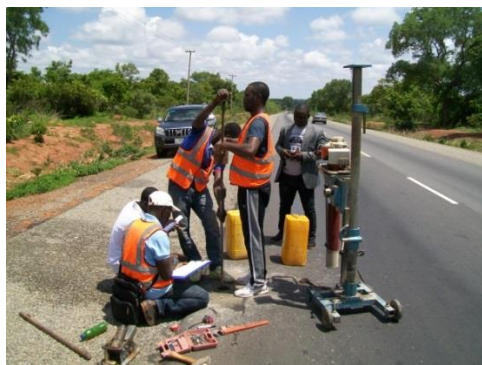
Fig. 4. Dynamic Cone Penetration test.

In conducting the DCP test, a light weight 8kg rammer, 60-degree cone head Dynamic Penetrometer was used. The number of blows for each 10cm penetration was recorded, and averages of number of the blows were used to calculate the CBR of the pavement structures. In estimating CBR of the pavement structures, the correlation (equation 1) advanced by TRL [36] was used.

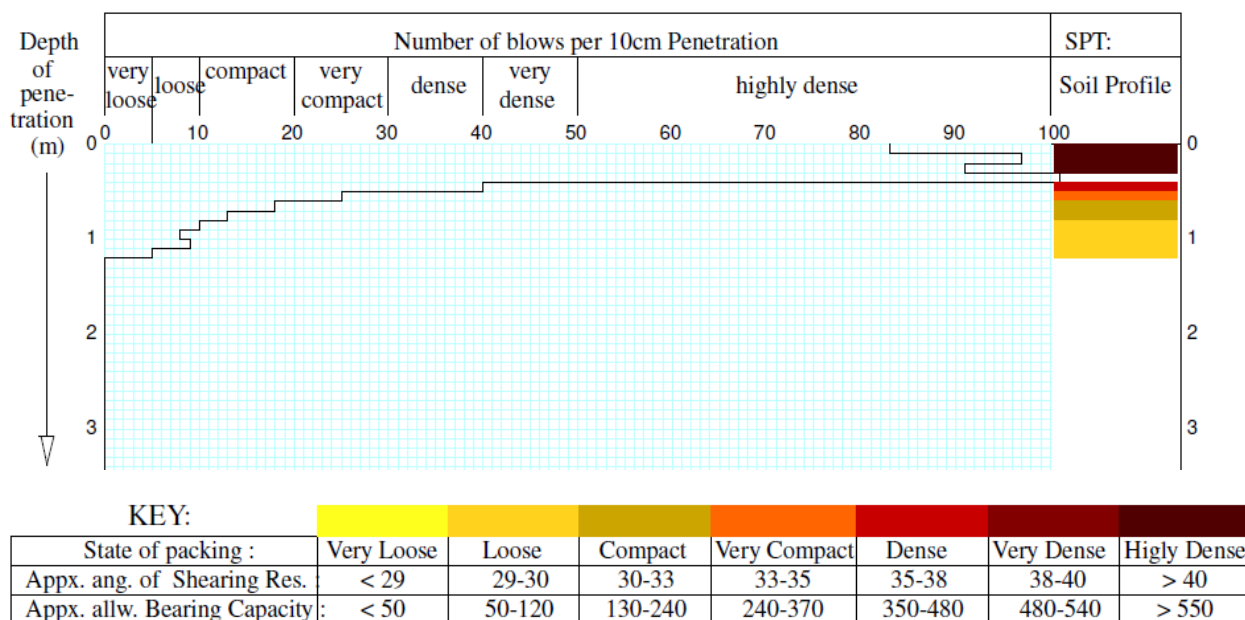
Fig. 5. DCPT Result for test location one (CH 18+600).

At the first test location (CH 18+600), repair work was observed to have been carried out at this location. Moderate fattening-up of bitumen and depression of the wearing course was noticed. Coring revealed thickness of the asphaltic concrete on this portion of the road to be 95mm. 200mm thick crushed stone base was observed to have been used at this location, while the sub-base course was of lateritic soil material, compacted to 200mm thick. The sub-grade material at this point was observed to be reddish sandy lateritic soil. The DCP result (Fig. 5) showed the base and sub-base courses at this location to be highly dense with average CBR values of 180 and 193% respectively, while the sub-grade, up to 600mm thick, ranges from dense to loose material with an average CBR value of 35% (Table 1).
